PROJECT FACT SHEET:

GREEN CREEK

CULVERT REPLACEMENT

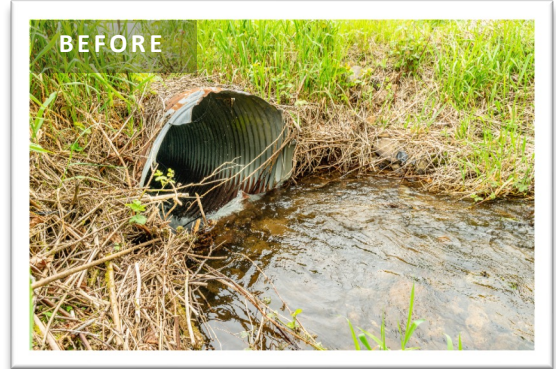
The failing culvert regularly plugged with debris causing flooding.

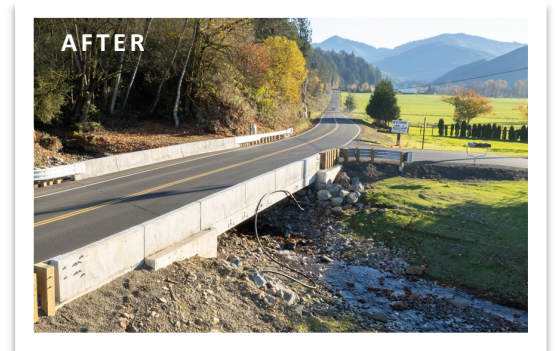
The completed bridge provides safe fish passage and ample room for debris to pass downstream.

The undersized culvert was removed and replaced with a 25' clear span bridge, restoring 1.7 miles of upstream spawning and rearing habitat. Having this bridge in place eliminates the flooding that frequently occurred with the undersized culvert. The streambed was reconstructed using streambed simulation methodology. This technique emulates the stream's natural bedform, including gravels and boulders, to create optimal fish habitat and passage.

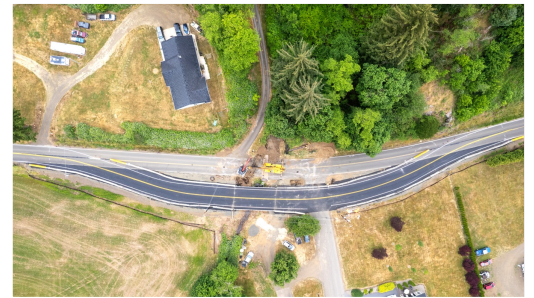
A temporary bypass bridge keeps traffic moving while the old culvert is replaced.

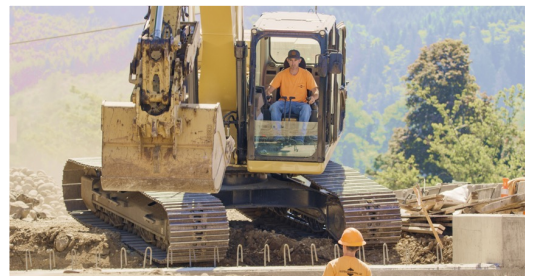
Placing boulders to protect the bridge footings.

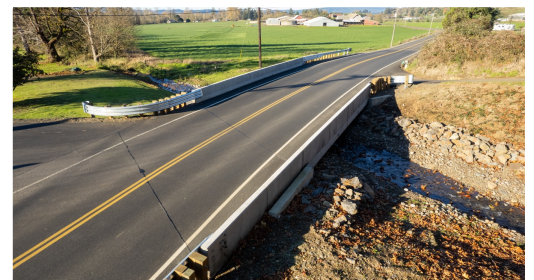
Most of the culverts replaced during Salmon SuperHwy projects are just as worn out and rusted as this one was. The new bridge is a much longer term solution and will keep this “Priority 1 Lifeline” road operational year-round for decades to come.
