PROJECT FACT SHEET:

SAMSON CREEK

PROJECT DESCRIPTION

CULVERT REPLACEMENT

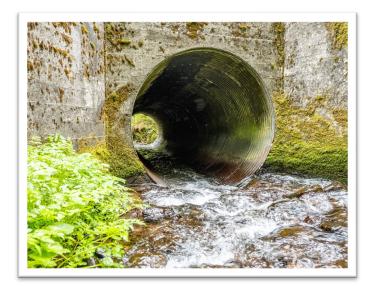
This undersized culvert also had a one-foot jump that not all fish could make.

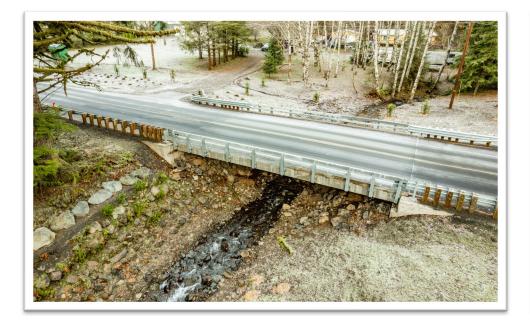
DURING: A temporary bypass bridge keeps traffic moving while the old culvert is replaced.

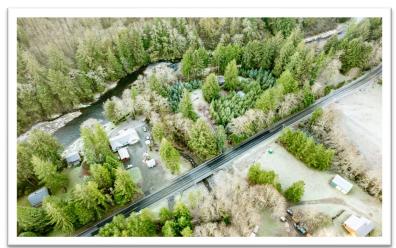
AFTER: Most of the culverts replaced during Salmon SuperHwy projects are just as worn out and rusted as this one was. The new bridge is a much longer term solution and will keep this "Priority 1 Lifeline" road operational year-round for decades to come.
